iRobot Roomba 560 Fan Replacement

Replace the fan inside of the Roomba 560's vacuum bin.

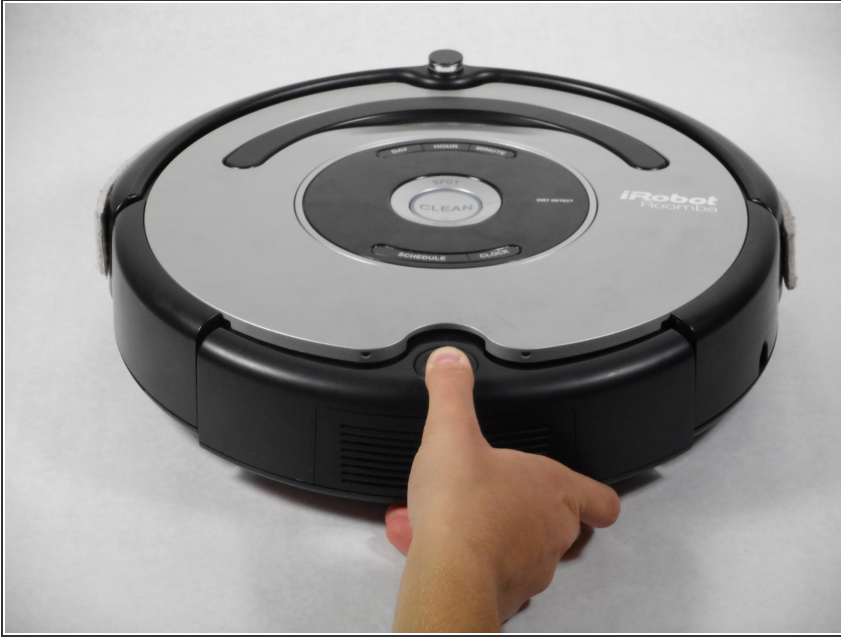
Step 1 — Fan

- Press the black circular button on the back end of the Roomba and pull the bin out towards you to remove the vacuum bin.

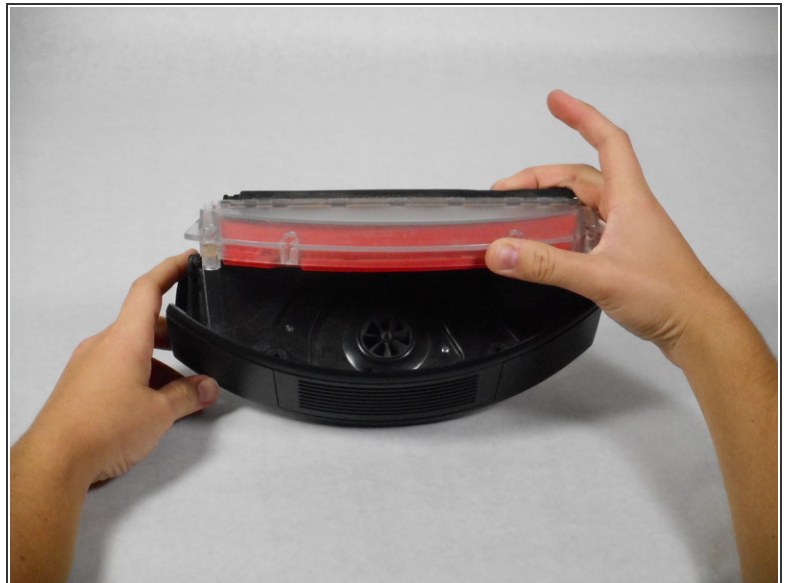
Step 2

- Lay the vacuum bin down and remove the six 15 mm screws around the outside of the vacuum bin using the Phillips JIS #1 driver.
- Remove the top of the vacuum bin by pulling it straight up.
 - ⚠ The bin is composed of two parts (the clear top casing and the red bottom filter). To avoid a mess, be careful to not let these two pieces detach, unless over a trash bin.

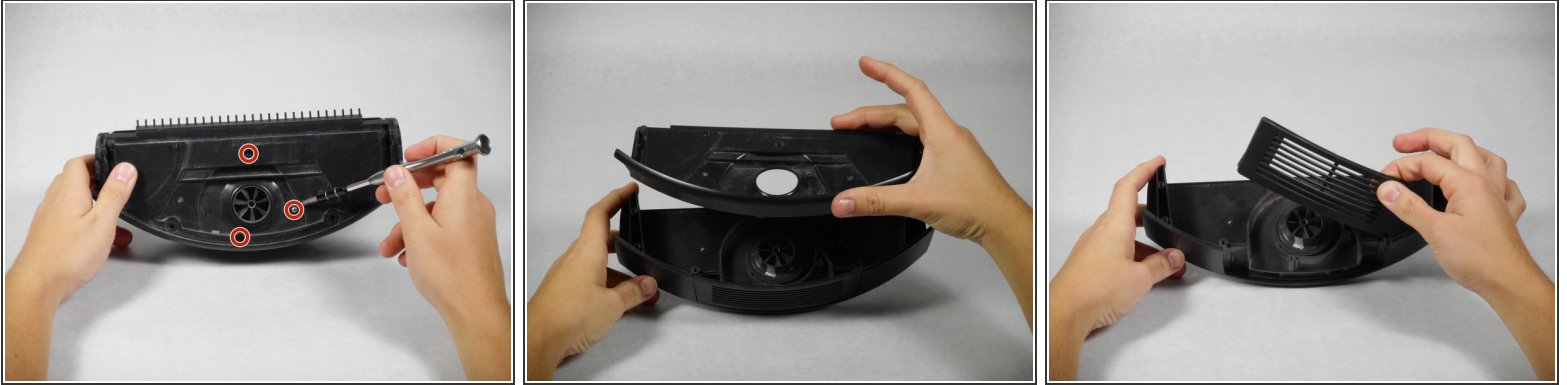
Step 3

- Remove the three 10 mm screws that surround the fan using the Phillips JIS #1 driver.
- Remove the casing that surrounds the fan by pulling it straight up.
- ⓘ The casing is composed of 2 parts (the large top casing, and a small air filter). If these parts detach, they are very easy to put back together. Do not lose the air filter.

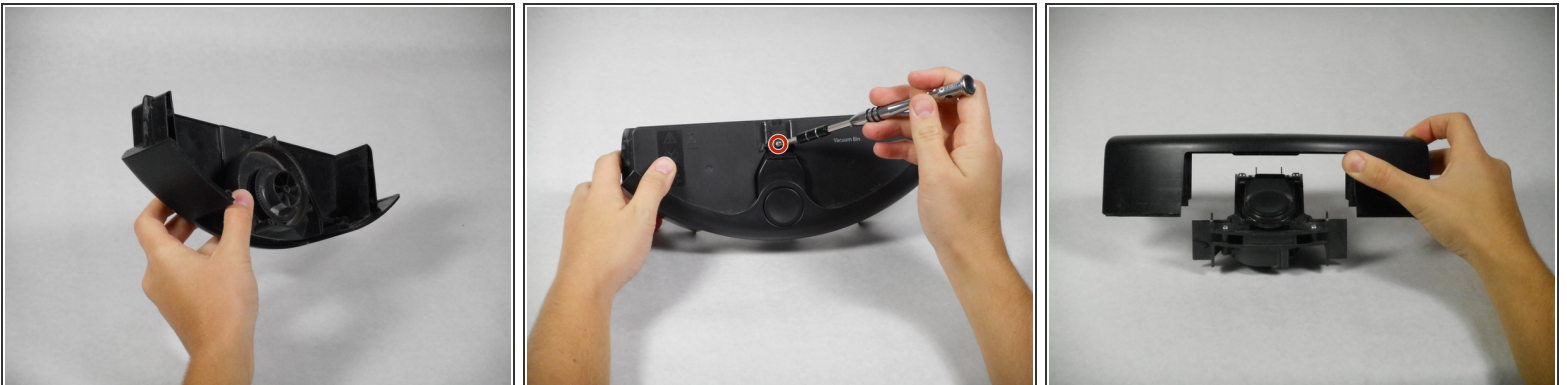
Step 4

- Turn over the remainder of the fan casing and remove the single 15mm screw, using the Phillips JIS #1 screwdriver.
- Remove the casing from the fan and battery component by pulling it straight up.
